## **Executive Summary**

# NASA-STD-3001 Technical Brief

## **EVA Mishaps**

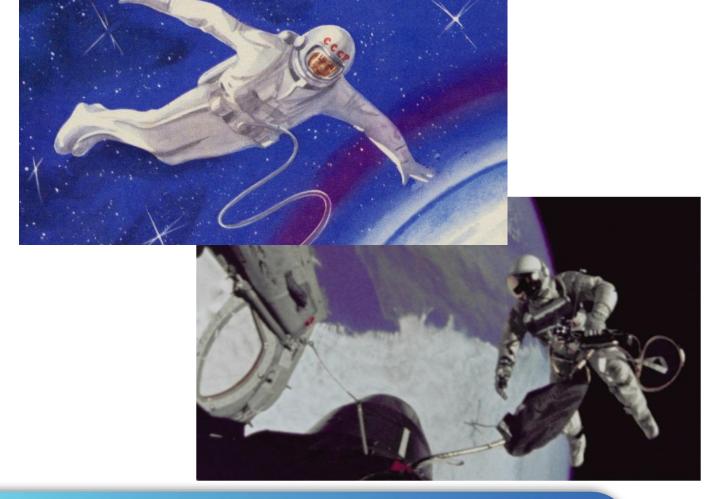
Voskhod 2 (pictured): The cosmonaut's suit ballooned, impeding maneuverability and ingress. He eventually had to let out some air from his suit to gain enough flexibility to re-enter the crew capsule. In addition, the workload of the spacewalk exceeded the ability of the suit's cooling system to maintain temperature. By the end of the EVA the suit was filled to the knees with perspiration.

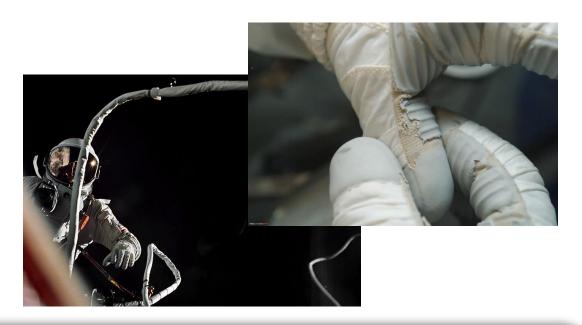
**Gemini 9 (pictured below-L):** Over the course of his spacewalk, Gene Cernan's EVA suit became frayed and torn in spots along his back. As a result, he experienced painful heat exposure and suffered burns. Additionally, the workload required by the EVA overloaded the suit's cooling system; Cernan became overheated and exhausted, and his visor completely fogged up.

**STS-37/118/125 (pictured below-R):** At some point during each of these missions, an astronaut's glove was cut or punctured. These were likely caused by normal wear and tear, as well as handling equipment which may have had burrs or sharp edges.
